# Manhole Inspection Summary

Manhole # S69S\_\_007MH

Insp Date: **5/16/08 10:27 AM**

**Location** Address: **6600 Hartwait St.**

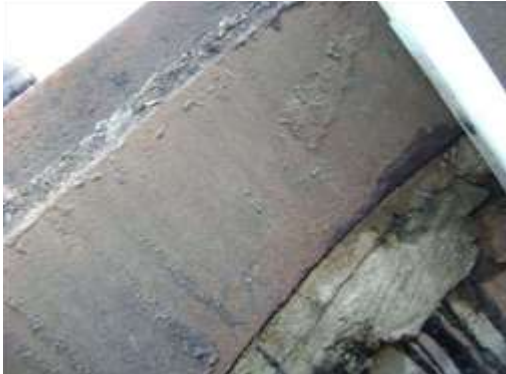
Defect 1

Condition: ☐ Sound ☐ Cracked ☐ Root Intrusion ☒ **Loose Brick** ☒ **Deteriorated**

Infiltration: ☐ None ☐ Joint ☐ Cracks ☒ **Mortar** ☐ Roots ☐ Wall

cracked mortar at frame seal

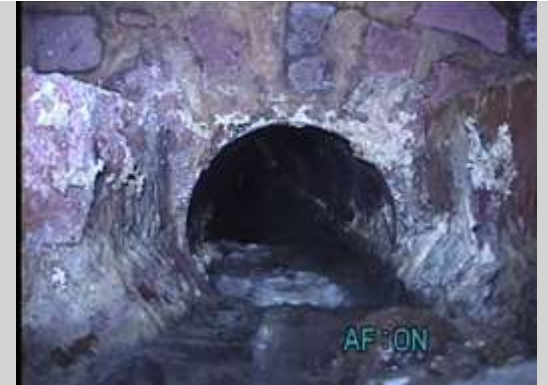
12 O'Clock Outflow

8 in. Circular Gravity Sewer  
Pipe Out @ 12 O'Clock

Pipe Height: **8.4** (in.) Rod and Bar (Angled)  
Pipe Material: **Clay** ☐ Pipe Lined  
Invert Depth: **13.83** (ft.) Flow Characteristics: **Slow**  
Deposits: ☐ None ☐ Mud ☐ Sludge ☒ **Debris** ☐ Grease  
Silt Depth: **1** (in.) Deposits Extent: **Light**  
Infiltration: **None** Pipe Seal Cond: **Sound**

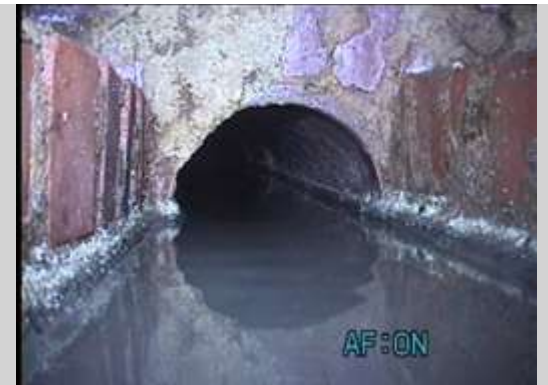
6 O'Clock Inflow

8 in. Circular Gravity Sewer  
Pipe In @ 6 O'Clock

Pipe Height: **8.4** (in.) Rod and Bar (Angled)  
Pipe Material: **Clay** ☐ Pipe Lined  
Invert Depth: **13.58** (ft.) Flow Characteristics: **Slow**  
Deposits: ☐ None ☐ Mud ☒ **Sludge** ☐ Debris ☐ Grease  
Silt Depth: **0.75** (in.) Deposits Extent: **Light**  
Infiltration: **None** Pipe Seal Cond: **Sound**

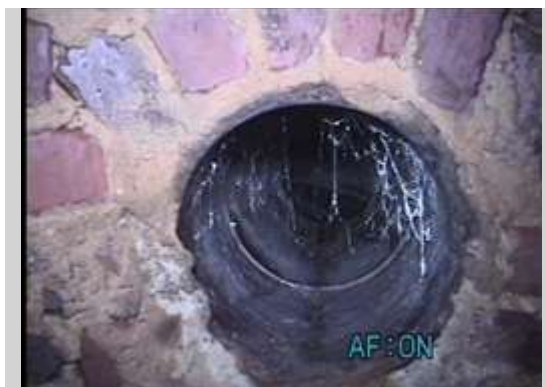
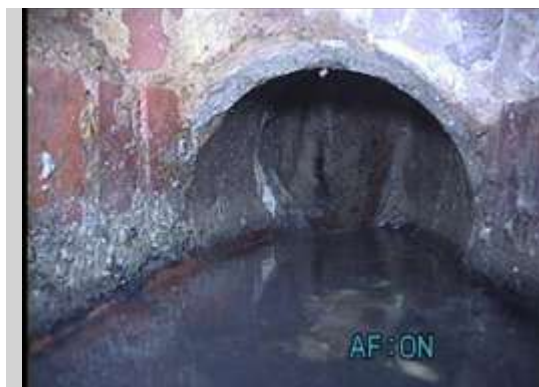
9 O'Clock Inflow

Drop: **Outside** Rod and Bar

Angled: **Yes** Reading: **12.50** (ft.)

Inv Depth: **13.50** (ft.)

Drop Condition: **Open**
